## Museum Fire - Flagstaff, Arizona

### Flagstaff Watershed Protection Project

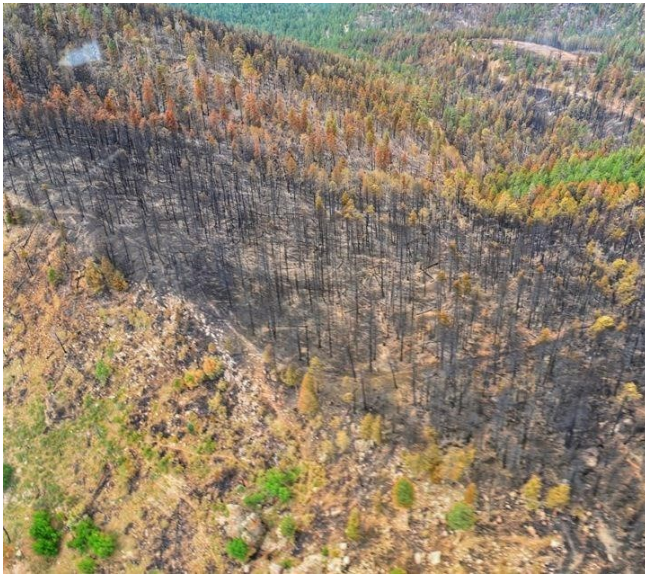
Aerial image of the variable fire severity within the Museum Fire. Photo courtesy of Coconino National Forest.

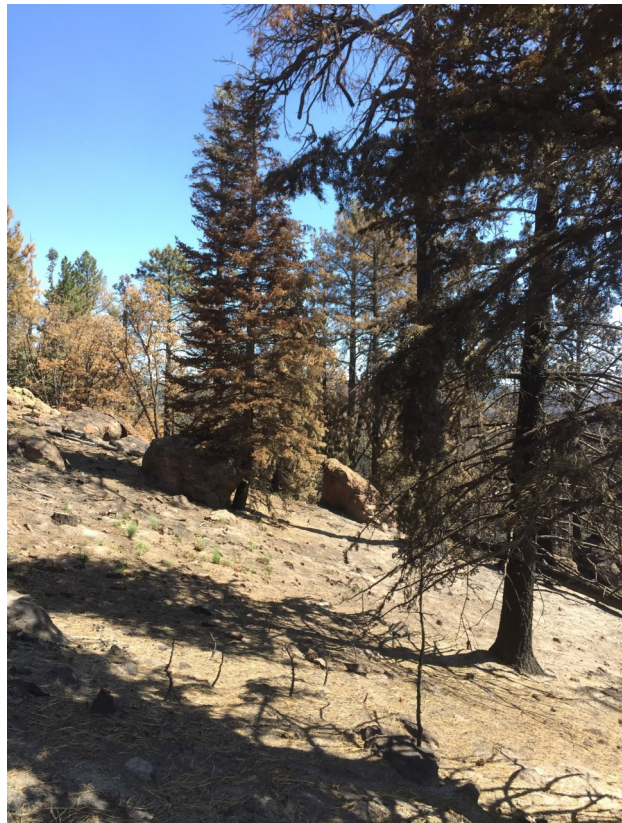
Approximate point of origin. Fire investigators and the U.S. Forest Service suggest it's likely that equipment approached this steep slope from the top of the ridge where a high elevation meadow leads into it. Photo by B. Satink Wolfson.
