SOUTHWEST FIRE SCIENCE CONSORTIUM

Slide Fire Suppression Effort

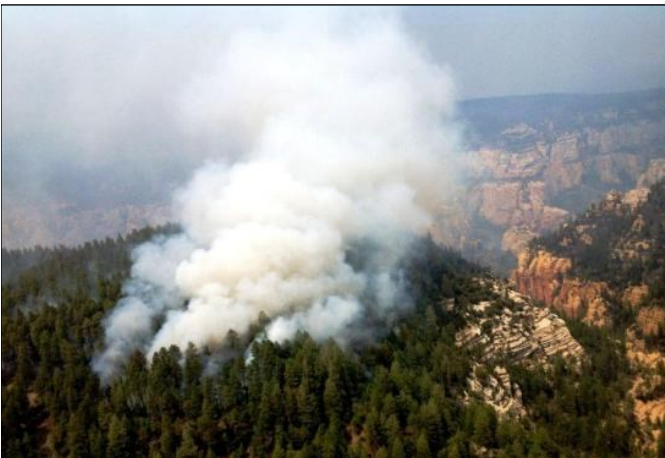
Ariel view of the Slide Fire. Photo courtesy of USDA Forest Service.

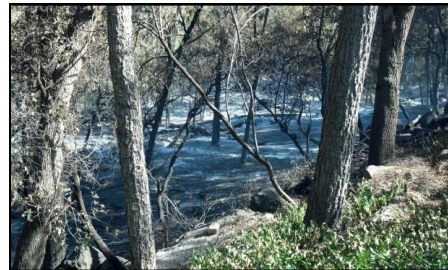
Effective use of defensible space created by a landowner. Photo courtesy of USDA Forest Service.
